BUREAU OF LAND MANAGEMENT

RE: Minor Modification to the Skyline Mine No. 3 - Relocating Setup Room and Bleeder Entries for the 5th Right Longwall Panel

UTAH FUEL COMPANY
SKYLINE MINE No. 3
LOWER O'CONNOR-A SEAM
Original Plan

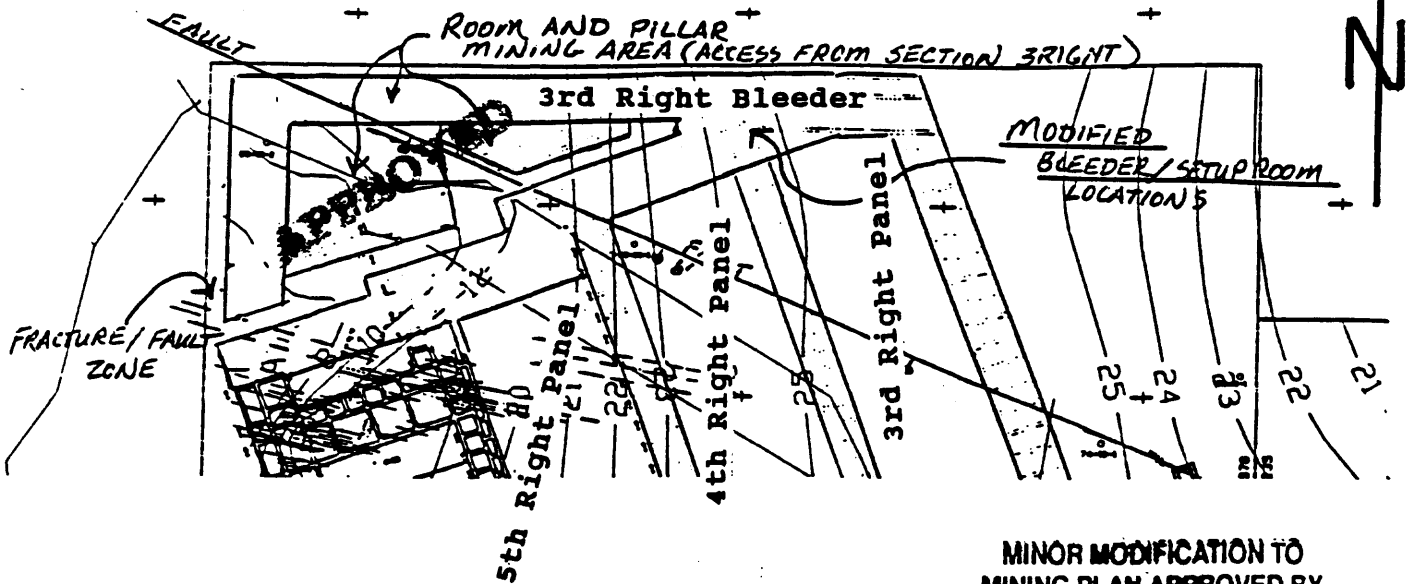
ENCLOSURE 1

The approved mining plan was to develop setup room and bleeder entries for the 5th Right longwall panel between #69 and #71 crosscuts of the 5th Right Headgate (see Enclosure 1). UFC is now proposing to develop the setup room and bleeder entries between #65 and #68 crosscuts. UFC also proposes to mine the block of coal between #68 and #71 crosscuts from the 3rd Right bleeder entries utilizing room-and-pillar mining practices (see Enclosure 2).
